DEPARTMENT OF TRANSPORTATION

Quality Assurance and Source Inspection

Contract #: 04-0120F4Cty: SF/ALA Rte: 80 PM: 13.2/13.9File #: 1.28**WELDING INSPECTION REPORT****Resident Engineer:** Casey, William**Address:** 333 Burma Road**City:** Oakland, CA 94607**Report No:** WIR-027804**Date Inspected:** 21-Jun-2012**Project Name:** SAS Superstructure**OSM Arrival Time:** 700**Prime Contractor:** American Bridge/Fluor Enterprises, a JV**OSM Departure Time:** 1730**Contractor:** American Bridge/Fluor Enterprises, a JV**Location:** Job site**CWI Name:** As Noted Below**CWI Present:** Yes No**Inspected CWI report:** Yes No N/A**Rod Oven in Use:** Yes No N/A**Electrode to specification:** Yes No N/A**Weld Procedures Followed:** Yes No N/A**Qualified Welders:** Yes No N/A**Verified Joint Fit-up:** Yes No N/A**Approved Drawings:** Yes No N/A**Approved WPS:** Yes No N/A**Delayed / Cancelled:** Yes No N/A**Bridge No:** 34-0006**Component:** OBG/Tower**Summary of Items Observed:**

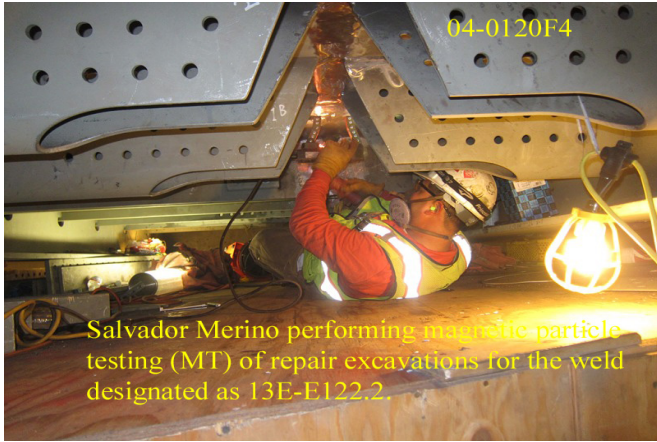
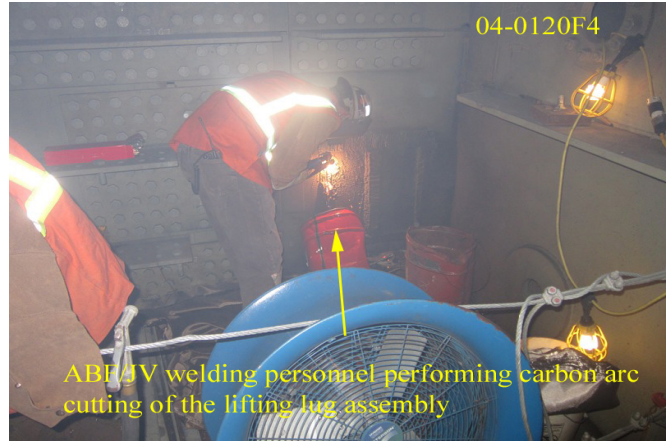
The QA inspector observed ABF/JV welding personnel performing carbon arc cutting of the lifting lug assembly in order to remove the remaining assembly from the longitudinal diaphragm that was previously utilized to lift the OBG to the temporary structure. The lifting lugs were removed to facilitate the fit up of additional stiffeners to the longitudinal diaphragm at a later date as seen in the attached photograph.
